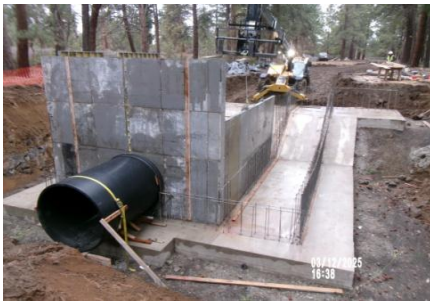
Contractor completed foundation slab for Intake Structure Sta. 718+00, template set 60-IN ID HDPE entrance pipe spool with seep ring, and is in process of erecting formwork for walls. Foundation slab dimensions as shown Dwg SD4, elevations as directed CO 01 - Intake Structure Location. Reinforcing steel for foundation slab per Drawing details SD1, SD2, SD3, and SD4. Reinforcing steel in accordance with approved Submittal 024.2 - Inlet Structure Rebar Dwgs R3. 60-IN ID HDPE entrance pipe spool per approved Submittal 16.1 - Krah HDPE Pipe Rev.2. Spool pipe template set at Intake Structure headwall as shown Drawings SD2 and SD4 (Photo).

AID MCPH2 - Sta 718+00 Intake Structure wall form erection 03-05-25

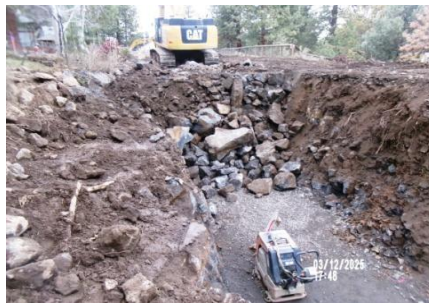
Contractor continued pipe trench excavation for installation 54-IN ID Profile Wall HDPE pipe and fabricated fittings. Trench excavation in progress approx Sta. 788+00 westbound. Excavation in approx 1 foot sandy silt and gravel with broken rock, underlain by hard rock. Trench excavation on line and grade per Drawing Sheet 14 of MCPH2, Seg2 Drawings. Work in accordance with spec 02300 - Earthwork (Photo).

Contractor continues placement and grading pipe bedding material for installation 54-IN Profile Wall HDPE. Pipe bedding material placement, final grading, and compaction in progress approximate Sta. 788+00 westbound. Pipe bedding material; 3/4"-0 Aggregate On-site Processed per approved Submittal 25 in accordance with spec 02300 - Earthwork. Contractor finish grading pipe bedding material using laser level take-off from constructions staking hubs. Densification of pipe bedding material provided with medium weight vibratory plate (Photos).

AID MCPH2 - Sta 788+00 54-IN ID profile wall HDPE pipe trench excavation and placement pipe bedding mtrl 03-12-25

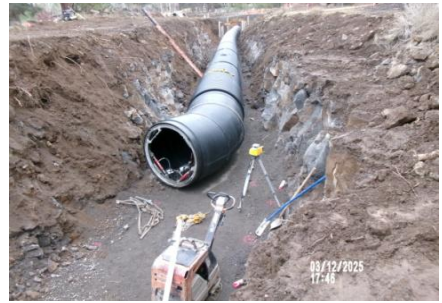
Contractor continues installation 54-IN ID profile wall HDPE pipe by Krah USA. Pipe materials conforming with specification 15068 and approved submittal 16.1 - Krah HDPE Pipe Rev.2. Electro-fusion of field pipe joints with IntegriFuse Electrofusion Processor Serial No. 00653, 00657, 00665, and 00667. Field welded pipe joints subject to air pressure testing; 25 psig, 5 minutes, PASS criteria: no pressure loss. Air testing of completed field joints in accordance with pipe manufacturers written instructions. Electro-fusion data and air pressure test data recorded and posted to the project record. Installation of 54-IN ID RSC400 pipe in progress approximate Sta. 788+37 westbound.

AID MCPH2 - Sta 788+37 54-IN ID profile wall HDPE pipe install and field joint fusion 03-12-25

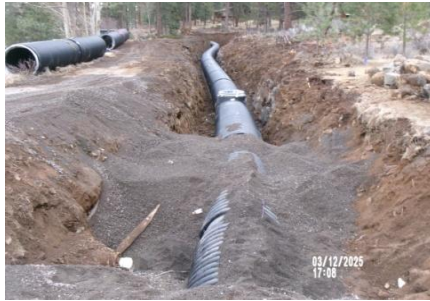
AID MCPH2 - Sta 791+00 54-IN ID profile wall HDPE pipe installed east of Woodside Road 03-12-25

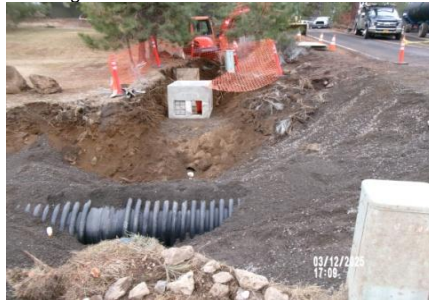
- 1) Type B Trench backfill material bedding of existing utilities overcrossing MCHP2 Seg pipe Sta. 791+00.
- 2) Install MCHP2 Seg pipe with 24" width btwn pipe and trench sidewall to afford specified densification of pipe zone backfill material.

AID MCPH2 - Sta 791+00 54-IN ID profile wall HDPE pipe undercrossing Roats Water and CEC 03-12-25

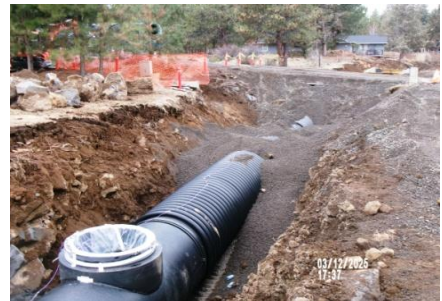
Contractor placed Type B Trench backfill material at 54-IN ID profile wall HDPE pipe installed Sta. 790+75 at public roadway crossing (Woodside Road). Type B trench backfill material 3/4"-0 Base Course Aggregate per approved Submittal 020 - Aggregate Base 3/4"-0 State Spec in accordance with specification 02300 - Earthwork. Densification of pipe trench final backfill to 95% maximum dry density modified Proctor, AASHTO T-180. Type B trench backfill density test results Sta. 790+75 pending publication.

AID MCPH2 - Sta 791+5 54-IN ID profile wall HDPE x 36-IN CO Assly riser + Type B Trench backfill Woodside Rd 03-12-25

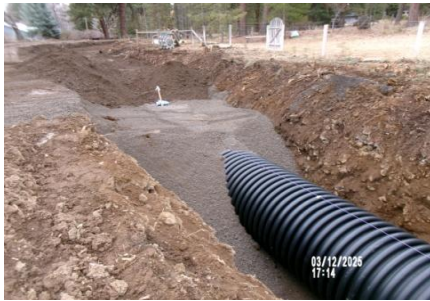
Contractor continued placement and densification of initial pipe zone backfill 54-IN ID profile wall HDPE pipe. Observed placement of purple tracer wire directly over the crown of installed pipe. Tracer wire product per approved Submittal 03 and spec 02300. Provisions made for tracer wire turnout to marking post in accordance with Drawing Dtl 1/D1 and 4/D2. Pipe zone material; 3/4"-0 aggregate processed on site from excavation spoils per approved Submittal 25. Pipe zone material placed in approximate 1 foot lifts and machine manipulated into intimate contact with the pipe in the pipe haunch zone. Compaction provided with excavator mounted sheeps foot roller. Placement and densification work in process Sta. 803+50 (Photo).

Contractor continued placement Type A trench backfill material over 54-IN ID profile wall HDPE pipe. Type A trench backfill substantially complete to approximate Sta. 803+50 westbound. Type A trench backfill material (final backfill) 3"-0 Type A Trench Backfill in accordance with specification 02300 - Earthwork, material processed on site. Densification of pipe trench final backfill provided with heavy track dozer. Noted installation detectable tape over pipe centerline approximately 24-inches above top crown. Detect tape in accordance with specification Section 23000 and approved Submittal 03.

AID MCPH2 - Sta 803+50 54-IN ID profile wall HDPE pipe, initial backfill w toning wire + detect tape 03-05-25

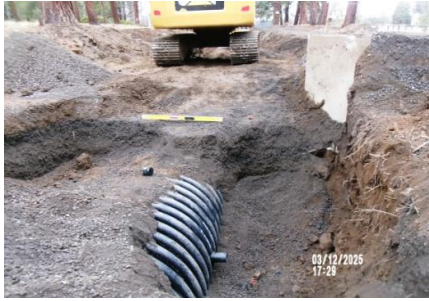
Contractor has initiated installation HAS turnouts MCHP2 Seg2 pipe, irrigation service assembly isolation butterfly valves, and irrigation service assemblies per Drawing details 3/D1, 5/D1, and 7/D1. HAS fittings materials and installation procedures conforming with specification 15068 and approved submittal 16.1 - Krah HDPE Pipe Rev.2. CEG provided QA visual assessment of 4-IN size HAS turnout installation Sta. 809+46 for 2-IN size irrigation service assembly 1-36152. No disqualifying factors noted in HAS turnout installation observed. Accepted field installed HAS turnout marked DP QA 03-12-25 (photos).

AID MCPH2 - Sta 809+46 4-IN HAS turnout to 1-36152, 2-IN Irrig Service Assly 03-05-25

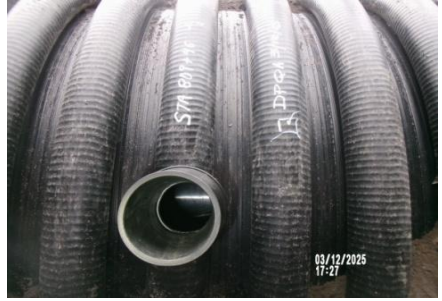
AID MCPH2 - Sta 809+46 4-IN HAS turnout to 1-36152, 2-IN Irrig Service Assly, QA Vis 03-05-25

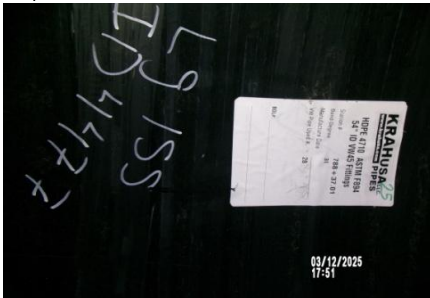
AID MCPH2 - Sta 788+37 54-IN ID profile wall HDPE fabricated fitting 31 degree bend 03-12-25

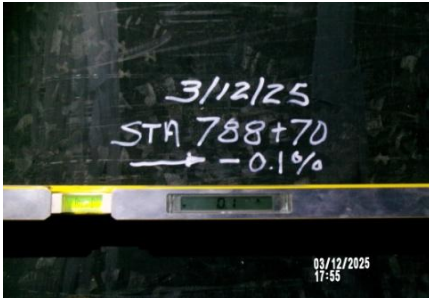
CEG conducted QA pipe slope measurement interior to installed 54-IN profile wall HDPE pipe using 4-ft smart level at pipe flow line. Sta. 788+70 slope = -0.1% (easterly) as measured on pipe interior flow line. Sta. 790+50 slope = -0.1% (easterly) as measured on pipe interior flow line (Photos). QA pipe slope measurement in general accord with pipe profile Sheet 14, design slope = -0.089%. (Photos).

AID MCPH2 - Sta 788+70 54-IN ID profile wall HDPE pipe QA pipe slope measurement -0.1% slope 03-12-25

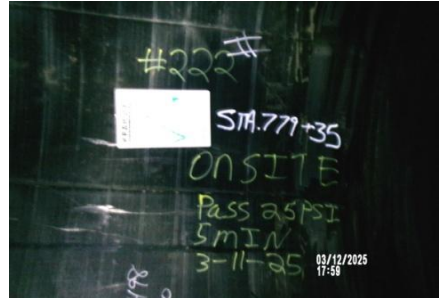
AID MCPH2 - Sta 789+35 54-IN ID profile wall HDPE pipe field joint #222 air pressure test PASS 03-12-25

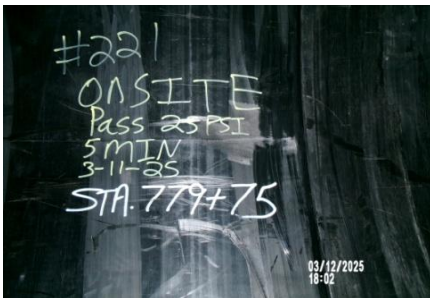
AID MCPH2 - Sta 789+75 54-IN ID profile wall HDPE pipe field joint #221 air pressure test PASS 03-12-25

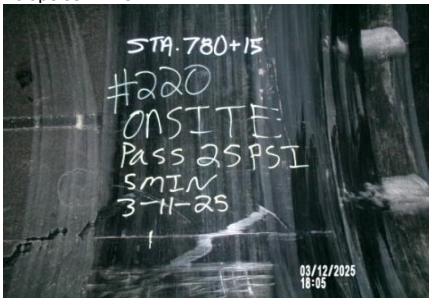
AID MCPH2 - Sta 790+15 54-IN ID profile wall HDPE pipe field joint #220 air pressure test PASS 03-12-25

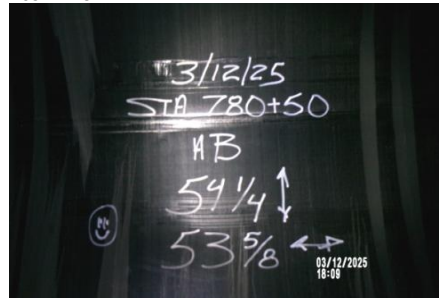
CEG conducted pipe ovality measurement installed 54-IN profile wall HDPE pipe using tape measured vertical and horizontal axis Sta. 790+50 at a location corresponding to Type B Trench backfill Woodside Rd crossing; vertical 54-1/4", horizontal 53-5/8" after backfill. Reference specification 02300 and 15068 for ovality criteria; 1% of pipe diameter = 1/2", ovality measurement Sta. 790+50 within allowable deflection limits, after backfill (Photo).

AID MCPH2 - Sta 790+50 54-IN ID profile wall HDPE pipe QA ovality measurement after backfill 03-12-25

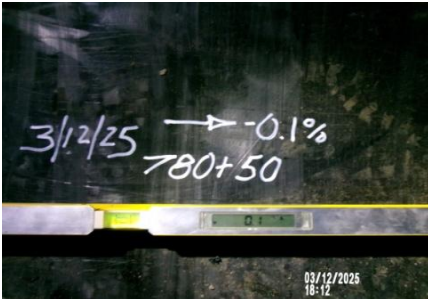
AID MCPH2 - Sta 790+50 54-IN ID profile wall
HDPE pipe QA pipe slope measurement -0.1%
slope 03-12-25
