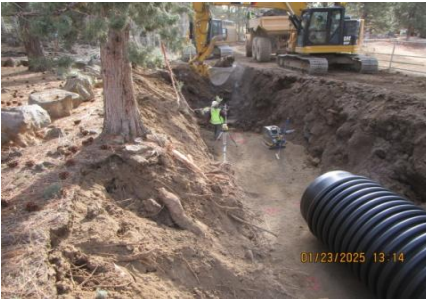
Contractor continues pipe trench excavation for install 54-IN ID Profile Wall HDPE pipe and fabricated fittings. Trench excavation complete to approximate Sta. 844+75. Trench excavation in progress approximate Sta. 844+75 westbound. Excavation in approximately 3 feet sandy silt, underlain by broken rock. Trench excavation on line and grade as shown Drawing Sheet 19 of MCPH2, Segment 2 Drawings. Work in accordance with specification 02300 - Earthwork. (Photo)

Contractor continues placement and grading pipe bedding material for installation 54-IN Profile Wall HDPE. Pipe bedding material placement and grading complete to approximate Sta. 844+60 westbound. Pipe bedding material placement, final grading, and compaction in progress approximate Sta. 844+55 westbound. Pipe bedding material; 3/4"-0 base course aggregate per approved Submittal 20 in accordance with specification 02300 - Earthwork. Contractor checking finish grade pipe bedding material using laser level take-off from constructions staking hubs. Densification of subgrade and pipe bedding material provided with medium weight vibratory plate. (Photo)

AID MCPH2 Seg2 - Sta. 844+75 trench excavation and bedding 54-IN ID profile wall HDPE pipe 01-23-25

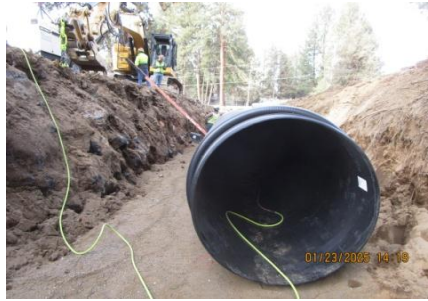
Contractor continues installation 54-IN ID profile wall HDPE pipe by Krah USA. Pipe materials conforming with specification 15068 and approved submittals. Electro-fusion of field pipe joints with Integrifuse Electrofusion Processor Serial No. 00665 (replacement unit for Serial No. 00667) and processor No. 00654. Field welded pipe joints subject to air pressure testing; 25 psig, 5 minutes, PASS criteria: no pressure loss. Air testing of completed field joints in accordance with pipe manufacturers written instructions. Witnessed air pressure test field joint No. 61 approximate Sta. 846+80, 48"-54" bladder test equipment, 75 psi bladder pressure, 25 psig test pressure, 5 minute air pressure test, PASS. Electro-fusion data and air pressure test data recorded and posted to the project record. Installation of 54-IN ID RSC400 pipe in progress approximate Sta. 845+10 westbound. (Photos)

AID MCPH2 - Sta 845+10 54-IN ID profile wall HDPE pipe setting and field joint electrofusion 01-23-25

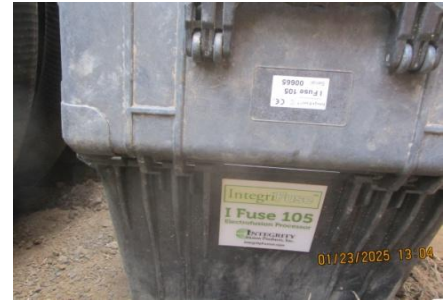
AID MCPH2 Seg2 - Sta. 846+33 54-IN ID profile wall HDPE pipe IntegriFuse Electrofusion Processor Serial 00665 (1) 01-23-25

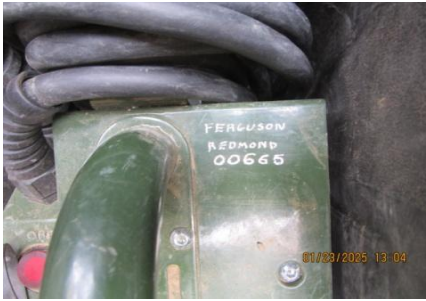
AID MCPH2 Seg2 - Sta. 846+33 54-IN ID profile wall HDPE pipe IntegriFuse Electrofusion Processor Serial 00665 (2) 01-23-25

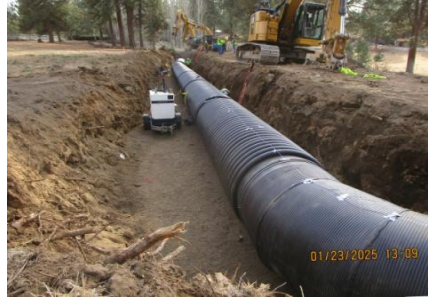
AID MCPH2 Seg2 - Sta. 846+70 54-IN ID profile wall HDPE pipe and fittings install 01-23-25

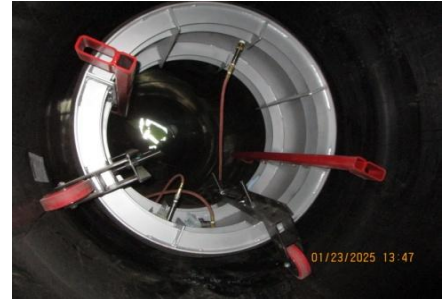
AID MCPH2 - Sta 846+80 54-IN ID profile wall HDPE pipe field joint 25 psi pressure test equipment 01-23-25

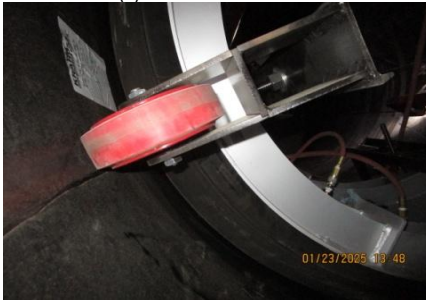
AID MCPH2 - Sta 846+80 54-IN ID profile wall HDPE pipe field joint 25 psi pressure test bladder 01-23-25

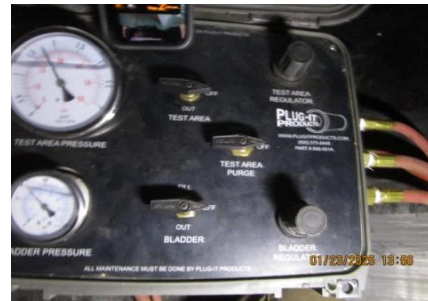
AID MCPH2 - Sta 846+80 54-IN ID profile wall HDPE pipe field joint 25 psi pressure test controller 01-23-25

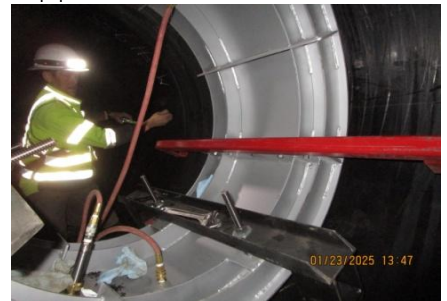
AID MCPH2 - Sta 846+80 54-IN ID profile wall HDPE pipe field joint #61, 25 psi pressure test PASS 01-23-25

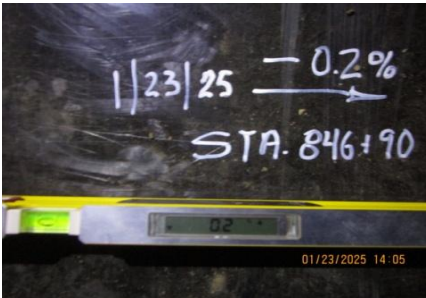
Conducted slope measurement installed 54-IN profile wall HDPE pipe using 4-ft smart level at pipe flow line. Slope -0.20% (East) measured on pipe interior flow line Sta. 846+90. Slope -0.10% (East) measured on pipe interior flow line Sta. 847+10. QA pipe slope measurement in general accord with pipe profile Sheet 19, design slope = -0.05%. (Photos)

AID MCPH2 - Sta 846+90 54-IN ID profile wall HDPE pipe QA slope measurement -0.2% slope 01-23-25

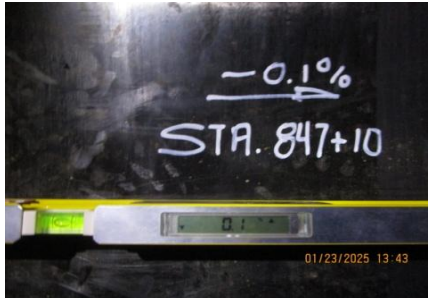
AID MCPH2 - Sta 847+10 54-IN ID profile wall HDPE pipe QA slope measurement -0.1% slope 01-23-25

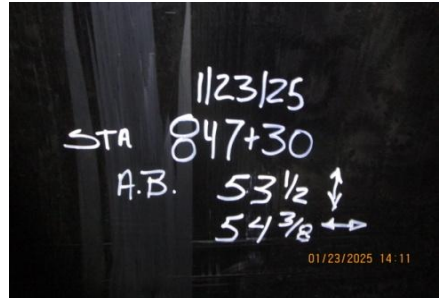
Conducted ovality measurement installed 54-IN profile wall HDPE pipe using tape measure vertical and horizontal axis Sta. 847+30; vertical 53-1/2" horizontal 54-3/8", after backfill. Reference specification 02300 and 15068 for ovality criteria; 1% of pipe diameter = 1/2", ovality measurement Sta. 847+30 within allowable deflection limits, after backfill. (Photo.)

AID MCPH2 - Sta 854+30 54-IN ID profile wall HDPE pipe QA ovality measurement after backfill 01-23-25

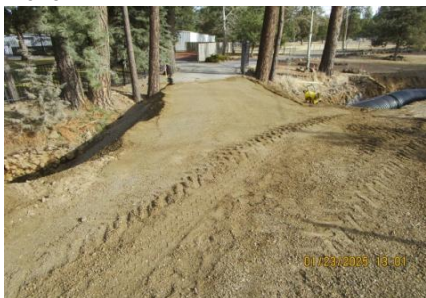
Contractor placed Type B Trench backfill material at 54-IN ID profile wall HDPE pipe installed Sta. 847+30. Type B trench backfill material 3/4"-0 Base Course Aggregate per approved Submittal 020 - Aggregate Base 3/4"-0 State Spec in accordance with specification Section 02300. Densification of pipe trench final backfill provided with excavator mounted compaction plate. (Photos).

AID MCPH2 Seg2 - Sta. 847+30 54-IN ID profile wall HDPE pipe, Type B Trench backfill (2) 01-23-25

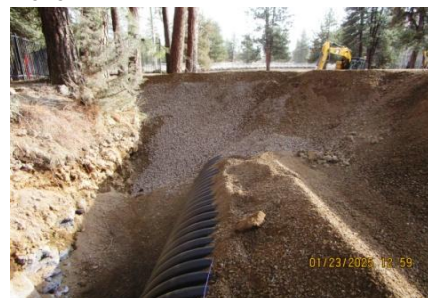
AID MCPH2 Seg2 - Sta. 847+30 54-IN ID profile wall HDPE pipe, Type B Trench backfill (1) 01-23-25

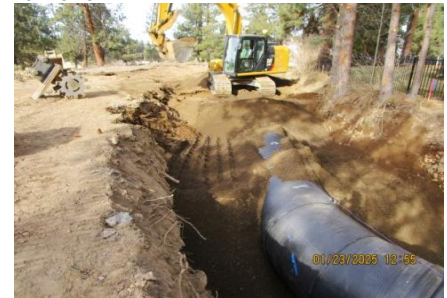
Contractor continued placement and densification of pipe zone backfill 54-IN ID profile wall HDPE pipe. Observed placement of purple tracer wire directly over the crown of installed pipe. Tracer wire product per approved Submittal 03 and spec Section 02300. Provisions made for tracer wire turnout to marking post in accordance with Drawing Dtl 1/D1 and 4/D2. Pipe zone material; 3/4"-0 Base Course Aggregate per approved Submittal 020 - Aggregate Base 3/4"-0 State Spec. Pipe zone material placed in approximate 1 foot lifts and machine manipulated into intimate contact with the pipe in the pipe haunch zone. Compaction provided with excavator mounted sheeps foot roller. Placement and densification work in progress approximate Sta. 848+30 westbound. (Photo.)

AID MCPH2 Seg2 - Sta. 848+30 54-IN ID profile wall HDPE pipe, pipe zone backfill and compaction 01-23-25

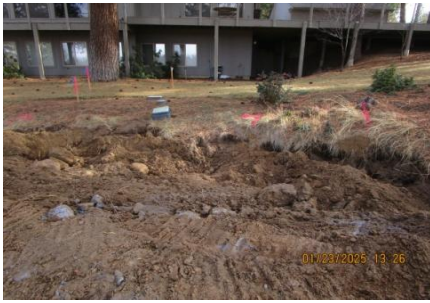
Noted Contractors potholing for reported private water and sewer utility crossing MCPH2 pipeline Sta. 843+10. Potholing conducted to MCPH2 pipe invert elevation Sta. 842+90 to 843+30, no utilities found in the trench profile. (Photos)

AID MCPH2 Seg2 - Sta. 843+10 + 20 ft - 20 ft
pothole for private water and sewer, none found
01-23-25

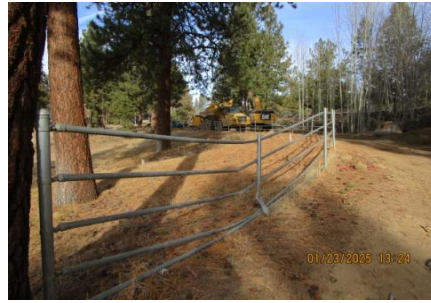
AID MCPH2 Seg2 - Sta. 842+75 damage existing
fence 01-23-25
