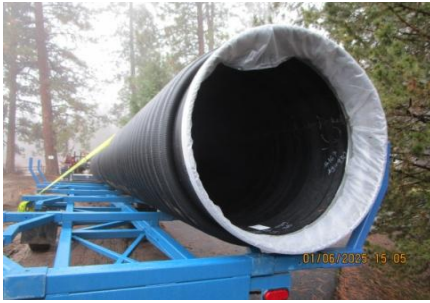
AID MCPH2 - 54-IN ID profile wall HDPE, RSC400, PE4710, ASTM F894 (1) 01-06-25

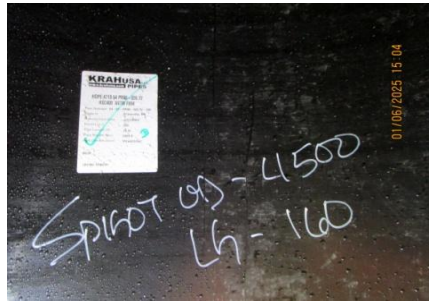
AID MCPH2 - 54-IN ID profile wall HDPE, RSC400, PE4710, ASTM F894 (2) 01-06-25

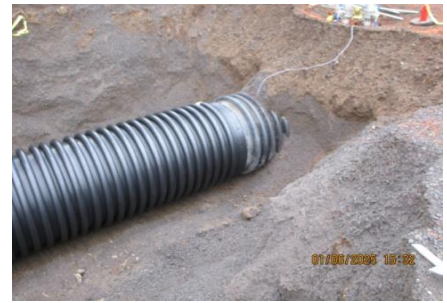
AID MCPH2 - Sta. 867+97 54-IN pipe, POC point-of-connection ex. 54-IN pipe 01-06-25

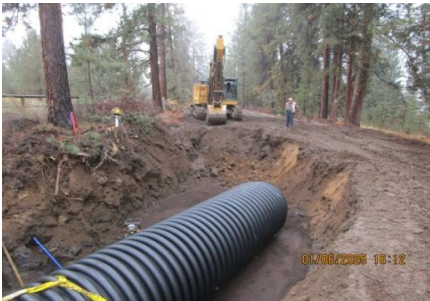
Contractor is engaged in pipe trench excavation for install 54-IN ID Profile Wall HDPE pipe. Trench excavation complete from approximate Sta. 866+00 to Sta. 867+98. Trench excavation in progress approximate Sta. 866+00 west. Excavation in sandy silt and broken rock. Trench excavation on line and grade as shown Drawing Sheet 20 of MCPH2, Segment 2 Drawings. Work in accordance with specification 02300 - Earthwork. Photo.

Contractor engaged in placement and grading of pipe bedding material for installation 54-IN Profile Wall HDPE. Pipe bedding material placement and grading complete approximate Sta. 866+00 to Sta. 867+98. Pipe bedding placement, final grading, and compaction in progress approximate Sta. 866+00 west. Pipe bedding material; 3/4"-0 crushed aggregate conforming with specification 02300 - Earthwork. Contractor checking finish grade pipe bedding material using laser level take-off from constructions staking hubs. Densification of subgrade and pipe bedding material provided by jumping jack tamper.

AID MCPH2 - Sta 866+00 54-IN pipe trench excavation + placement pipe bedding material + pipe setting 01-06-25

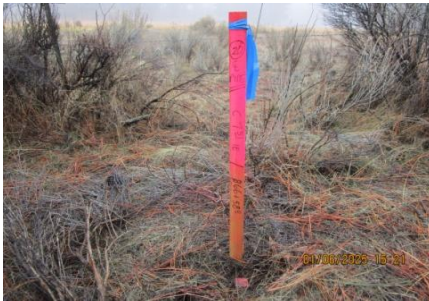
AID MCPH2 - Sta. 866+58 54-IN pipe construction staking, cut to invert 7.51-FT 01-06-25

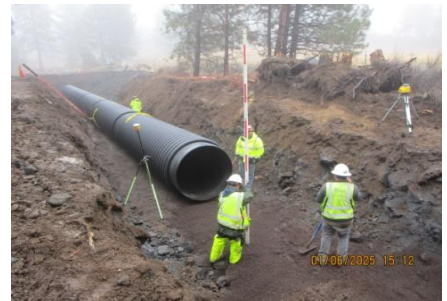
AID MCPH2 - Sta. 866+55 54-IN pipe, pipe setting + grade check in process 01-06-25

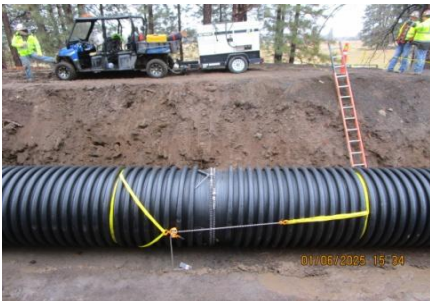
Contractor has initiated installation 54-IN ID profile wall HDPE pipe by Krah USA. Material in conformance with specification 15068 and approved submittals. Electrofusion of field joints Krah USA pipe by Contractor. Field fusion standard pipe joints with weld machine (not recorded). Fusion data and air pressure test data recorded. Installation of 54-IN ID RSC400 pipe in progress approximate Sta. 866+55 heading west. (2) field welded pipe joints subject to air pressure testing; 25 psig, 5 minutes, no pressure loss. Air testing of completed field joints in accordance with pipe manufacturers written instructions. Discussed with Contractor; air pressure test duration is 5 minutes minimum, no loss of air pressure allowed for acceptable field welded pipe joint.

AID MCPH2 - Sta. 866+93 54-IN pipe, field joint electrofusion in process 01-06-25

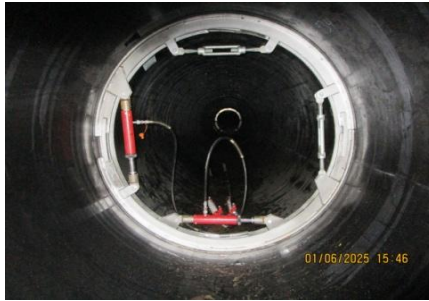
AID MCPH2 - 54-IN pipe, internal joint expander 01-06-25

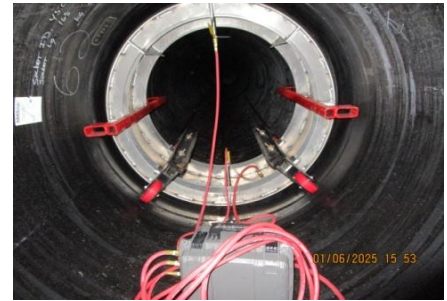
AID MCPH2 - 54-IN pipe, air test equipment 01-06-25

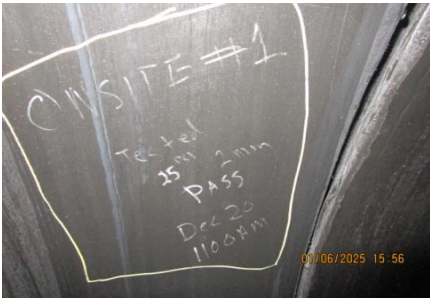
AID MCPH2 - Sta 867+97 POC existing 54-IN pipe, field weld #1, air test results 01-06-25

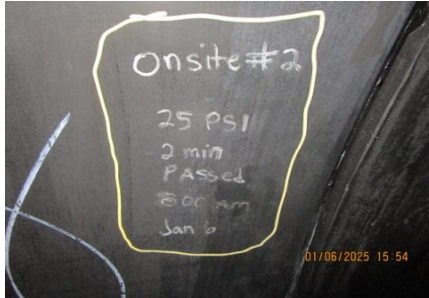
AID MCPH2 - Sta 867+45 POC existing 54-IN pipe, field weld #2, air test results 01-06-25

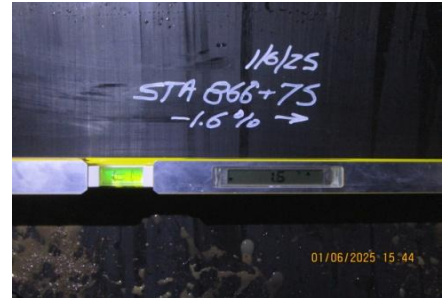
Conducted slope measurement installed 54-IN profile wall HDPE pipe using 4-ft smart level at pipe flow line. Slope -1.6% (East) measured on pipe interior Sta. 866+75. QA pipe slope measurement in general accord with pipe profile Sheet 20, design slope = -1.59%. Photo.

AID MCPH2 - Sta. 866+75 54-IN pipe, QA pipe slope measure 01-06-25

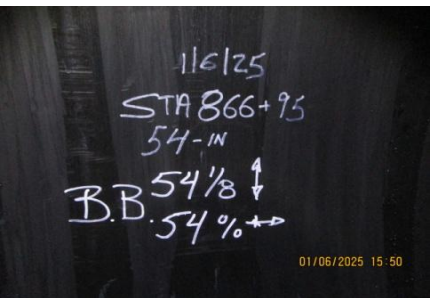
Conducted ovality measurement installed 54-IN profile wall HDPE pipe, prior to backfill, using tape measure vertical and horizontal axis Sta. 866+95; vertical 54-1/8" horizontal 54-0/0", before backfill. Reference Specification 02300 and 15068 for ovality criteria; 1% of pipe diameter = 1/2", ovality measurement Sta. 866+95 within allowable deflection limits, prior to backfill. Photo.

AID MCPH2 - Sta. 866+95 54-IN pipe, QA quality measure before backfill 01-06-25

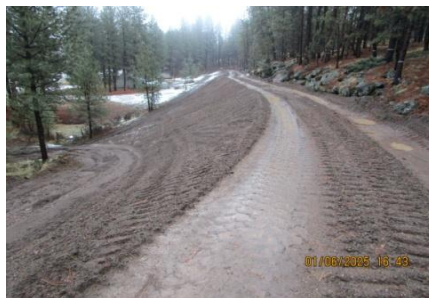
Contractor has substantially completed construction of embankment fill MCPH2 Sta. 816+50 to Sta 823+50.. Ref. Drawing Sheets 16 and 17 for layout. Ref. Drawing Sheet 27 for planned embankment fill sections. Ref. specification Section 02300 - Earthwork for key construction and embankment fill requirements. Embankment fill above the key constructed using 1.5-IN crushed aggregate placed in level, 1-foot lifts on terraced ground, densified with sheep-foot roller. Contractors QC density testing of embankment fill in accordance with specification Section 02300, Part 3.12 - Earth Fill / Embankment Fill. Contractor QC density test results complete, pending submittal.

AID MCPH2 - Sta 817+50 embankment fill complete 1.5-IN minus 01-06-25

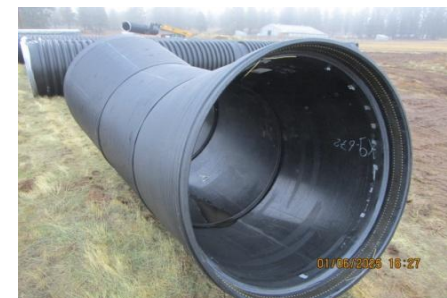
AID MCPH2 - Stored Mtrl 54-IN RSC400 profile wall pipe and fittings (1) 01-06-25

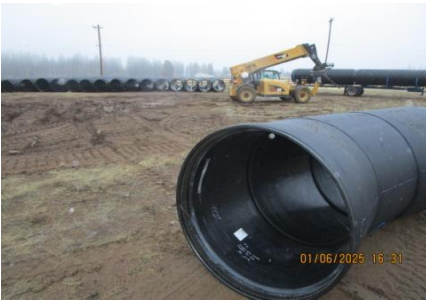
AID MCPH2 - Stored Material 54-IN RSC400 profile wall pipe and fittings (2) 01-06-25

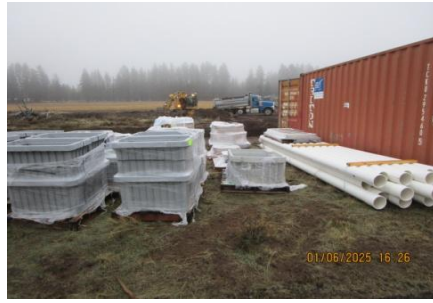
AID MCPH2 - Stored Material; meter boxes + valve riser pipe 01-06-25

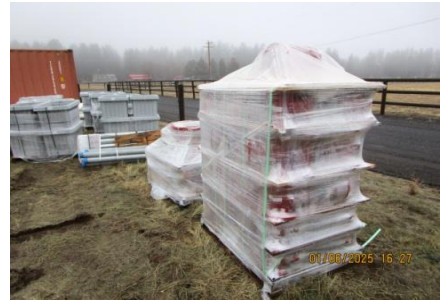
AID MCPH2 - Stored Material; gate valves + meter boxes 01-06-25
