DAILY MONITORING REPORT

PROJECT NAME: Arnold Irrigation District - MCPH2 Seg2 YR 2024 / 2025	CONTRACT NO: AID MCPH2 Piping Project
LOCATION / STA.: AID MCPH2 Segment 2	ID NUMBER: AID - MCPH2 Seg2

CONTRACTOR OR SUBCONTRACTOR: K&E Excavating, Inc.

PREPARED BY: David C. Prull - Clearwater Eng Grp	SHIFT: Day	S	M	T	✓	W	T	F	S	DATE: 4/1/2025
--	------------	---	---	---	---	---	---	---	---	----------------

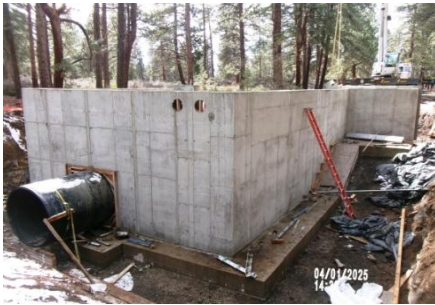
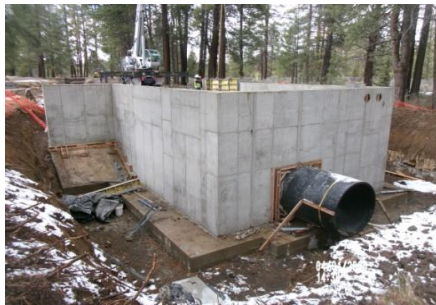
AID MCPH2 Seg2 - Sta. 718+00 Intake Structure wall form removal (1) 04-01-25

AID MCPH2 Seg2 - Sta. 718+00 Intake Structure wall form removal (2) 04-01-25

Contractor has completed foundation and wall construction Intake Structure Sta. 718+00, including 60-IN ID HDPE pipe entrance spool with seep ring. Foundation slab and wall dimensions as shown Dwg SD4, elevations as directed CO 01- Intake Structure Location. Reinforcing steel per Drawing details SD1, SD2, SD3, and SD4. Reinforcing steel in accordance with approved Submittal 024.2- Inlet Structure Rebar Dwgs R3. 60-IN ID HDPE entrance pipe spool per approved Submittal 16.1 - Krah HDPE Pipe Rev.2. Spool pipe template set at headwall as shown Drawings SD2 and SD4, invert elevation 3890.63. Concrete placed; Hooker Creek Mix 50SL428A at Intake Structure foundation and walls. Concrete in accordance with specification and approved Submittal 32 - Concrete Mix Design Alt 1 (4500 PSI). Contract work in progress this day includes wall form removal. No concrete placement defects observed. Cold weather concrete protection consisting of thermal blankets to be placed over walls until end 7-day cure period. (photos).

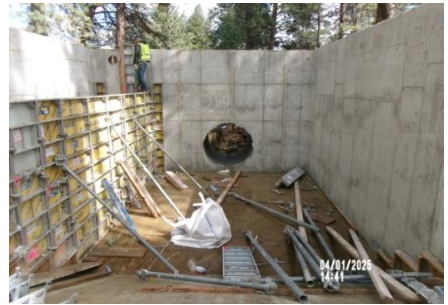
AID MCPH2 Seg2 - Sta. 718+00 Intake Structure, wall form removal, 60-IN ID pipe inlet 04-01-25

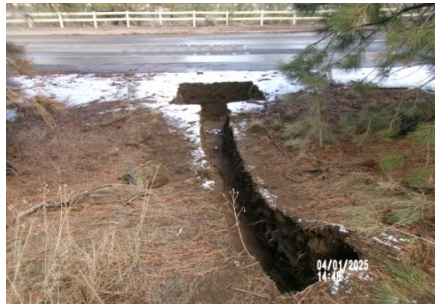
AID MCPH2 Seg2 - Sta. 719+00 existing electrical utility postholed, preparation for installation temp power service Intake Structure 04-01-25

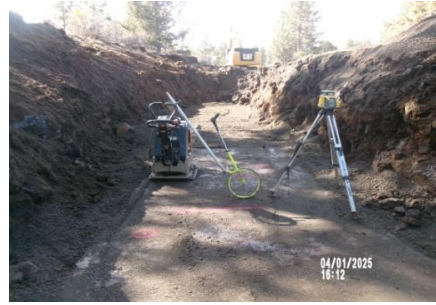
AID MCPH2 - Sta 767+50 54-IN ID profile wall HDPE pipe trench excavation and placement pipe bedding mtrl 04-01-25

Contractor continued pipe trench excavation for installation 54-IN ID Profile Wall HDPE pipe and fabricated fittings. Trench excavation in progress approx Sta. 767+50 westbound. Excavation in approx 2.5 ft sandy silt and gravel with broken rock, underlain by hard rock. Trench excavation on line and grade per Drawing Sheet 12 of MCPH2, Seg2 Drawings. Work in accordance with spec 02300 - Earthwork (Photo).

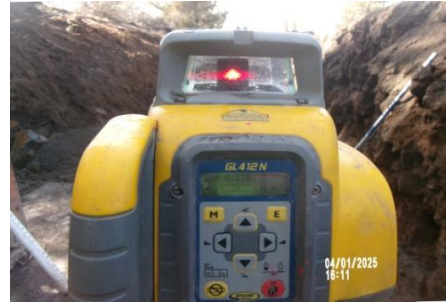
AID MCPH2 - Sta 768+00 54-IN ID profile wall HDPE pipe, placement pipe bedding mtrl 04-01-25

Contractor continues placement and grading pipe bedding material for installation 54-IN Profile Wall HDPE. Pipe bedding material placement, final grading, and compaction in progress approximate Sta. 768+00 westbound. Pipe bedding material; 3/4"-0 Aggregate On-site Processed per approved Submittal 25 in accordance with spec 02300 - Earthwork. Contractor finish grading pipe bedding material using laser level take-off from constructions staking hubs. Densification of pipe bedding material provided with medium weight vibratory plate (Photos).

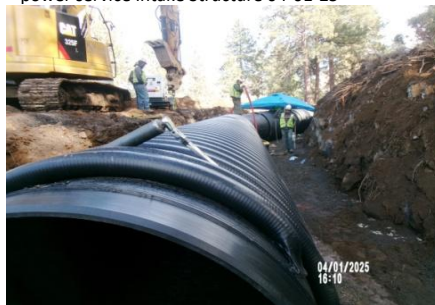
AID MCPH2 - Sta 769+25 54-IN ID profile wall HDPE pipe, installation and field joint fusion 04-01-25

Contractor continues installation 54-IN ID profile wall HDPE pipe by Krah USA. Pipe materials conforming with spec 15068 and approved submittal 16.1 - Krah HDPE Pipe Rev.2. Electro-fusion of field pipe joints with Integrifuse Electrofusion Processor Serial No. 00653, 00657, 00665, and 00667. Field welded pipe joints subject to air pressure testing; 25 psig, 5 minutes, PASS criteria: no pressure loss. Air testing of completed field joints in accordance with pipe manufacturers written instructions. Electro-fusion data and air pressure test data recorded and posted to the project record. Installation of 54-IN ID RSC400 pipe in progress approximate Sta. 769+25 westbound.

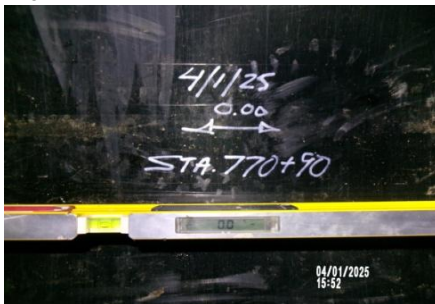
AID MCPH2 - Sta 770+90 54-IN ID profile wall HDPE pipe QA pipe slope measurement 0.0% level 04-01-25

CEG conducted QA pipe slope measurement interior to installed 54-IN profile wall HDPE pipe using 4-ft smart level at pipe flow line. Sta. 769+95 slope = -0.1% (easterly) as measured on pipe interior flow line. Sta. 770+90 slope = 0.0% (level) as measured on pipe interior flow line. QA pipe slope measurement in general accord with pipe profile Sheet 12, design slope = -0.110%. (Photos).

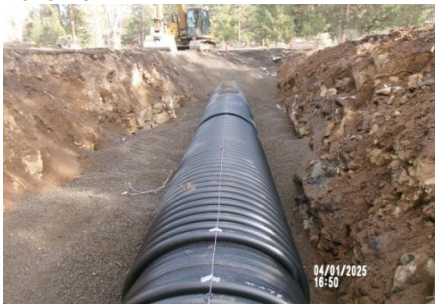
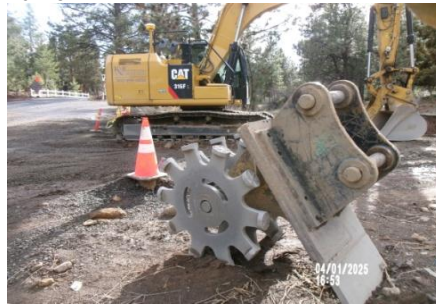
AID MCPH2 - Sta 790+25 54-IN ID profile wall HDPE pipe placement and densification Type A trench backfill (1) 04-01-25

AID MCPH2 - Sta 790+25 54-IN ID profile wall HDPE pipe placement and densification Type A trench backfill (2) 04-01-25

Contractor continued placement and densification of initial pipe zone backfill 54-IN ID profile wall HDPE pipe. Observed placement of purple tracer wire directly over the crown of installed pipe. Tracer wire product per approved Submittal 03 and spec 02300. Provisions made for tracer wire turnout to marking post in accordance with Drawing Dtl 1/D1 and 4/D2. Pipe zone material; 3/4"-0 aggregate processed on site from excavation spoils per approved Submittal 25. Pipe zone material placed in approximate 1 foot lifts and machine manipulated into intimate contact with the pipe in the pipe haunch zone. Compaction provided with excavator mounted sheeps foot roller. Placement and densification work in process approximate Sta. 790+25 (Photos).

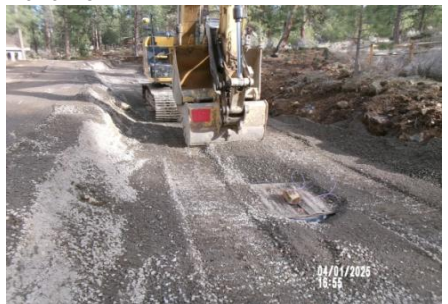
AID MCPH2 - Sta 791+50 54-IN ID profile wall HDPE pipe, 0.75-IN - 0 Aggregate Type A trench backfill in pipe zone 04-01-25
