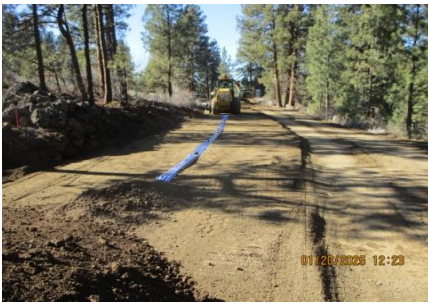
AID MCPH2 Seg2 - Sta. 855+00 54-IN ID profile wall HDPE pipe, Type A trench backfill + detect tape 01-20-25

Contractor continued placement Type A trench backfill material of 54-IN ID profile wall HDPE pipe Type A trench approximate Sta. 855+00 westbound. Type A trench backfill material (final backfill) 3/4"-0 Base Course Aggregate per approved Submittal 020 - Aggregate Base 3/4"-0 State Spec in accordance with specification Section 02300. Densification of pipe trench final backfill provided with large smooth drum roller. Noted installation detectable tape over pipe centerline approximately 18-inches above top crown. Detect tape in accordance with specification Section 23000 and approved Submittal 03.

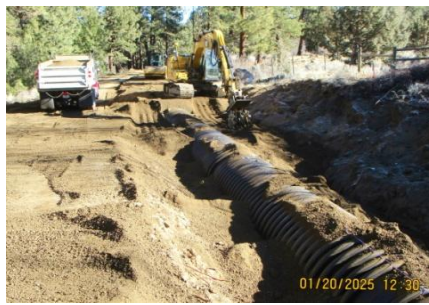
AID MCPH2 Seg2 - Sta. 852+50 54-IN ID profile wall HDPE pipe, pipe zone backfill and compaction 01-20-25

Contractor continued placement and densification of pipe zone backfill 54-IN ID profile wall HDPE pipe. Observed placement of purple tracer wire directly over the crown of installed pipe. Tracer wire product per approved Submittal 03 and spec Section 02300. Provisions made for tracer wire turnout to marking post in accordance with Drawing Dtl 1/D1 and 4/D2. Pipe zone material; 3/4"-0 Base Course Aggregate per approved Submittal 020 - Aggregate Base 3/4"-0 State Spec. Pipe zone material placed in approximate 1 foot lifts and machine manipulated into intimate contact with the pipe in the pipe haunch zone. Compaction provided with backhoe mounted sheeps foot roller. Placement and densification work in progress approximate Sta. 852+50 westbound. (Photo.)

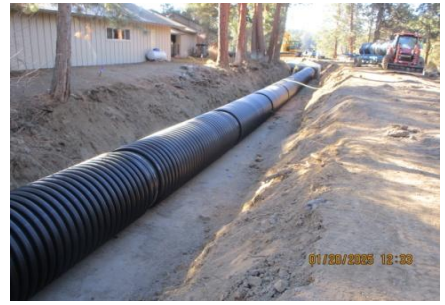
AID MCPH2 Seg2 - Sta. 851+50 54-IN ID profile wall HDPE pipe installed 01-20-25

Contractor continues installation 54-IN ID profile wall HDPE pipe by Krah USA. Material in conformance with specification 15068 and approved submittals. Electro-fusion of field joints by Contractor. Field electro-fusion of pipe joints with weld machines Serial No. 00667 and No. 00654. Field welded pipe joints subject to air pressure testing; 25 psig, 5 minutes, PASS criteria: no pressure loss. Air testing of completed field joints in accordance with pipe manufacturers written instructions (Photo). Electro-fusion data and air pressure test data recorded and posted to the project record. Installation of 54-IN ID RSC400 pipe in progress approximate Sta. 849+23 westbound. (Photos)

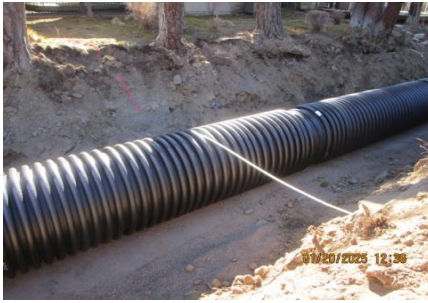
AID MCPH2 Seg2 - Sta. 850+80 existing private water 1-1.4-IN Pex, protect-in-place 01-20-25

Noted private water utility overcrossing MCPH2 pipeline Sta. 850+80, and (2) x 3-IN private water utilities overcrossing MCPH2 pipeline Sta. 848+00. Abandoned in place private irrigation utilities identified Sta. 850+25 and Sta. 847+90. (Photos).

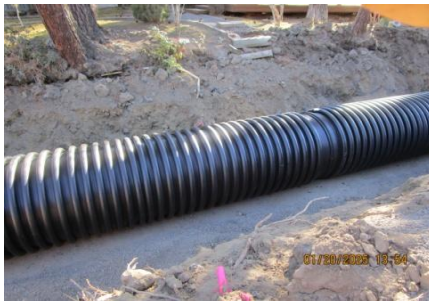
AID MCPH2 Seg2 - Sta. 850+25 private irrigation and electrical, abandoned in place 01-20-25

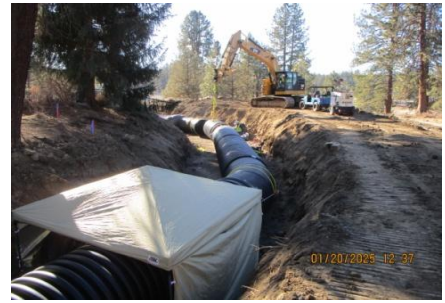
AID MCPH2 - Sta 849+75 54-IN ID profile wall HDPE pipe field joint welding provisions 01-20-25

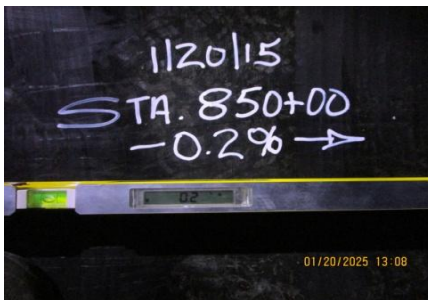
Conducted slope measurement installed 54-IN profile wall HDPE pipe using 4-ft smart level at pipe flow line. Slope -0.20% (East) measured on pipe interior flow line Sta. 850+00. QA pipe slope measurement in general accord with pipe profile Sheet 19, design slope = -0.05%. (Photo)

AID MCPH2 - Sta 850+00 54-IN ID profile wall HDPE pipe QA slope measurement -0.2% slope 01-20-25

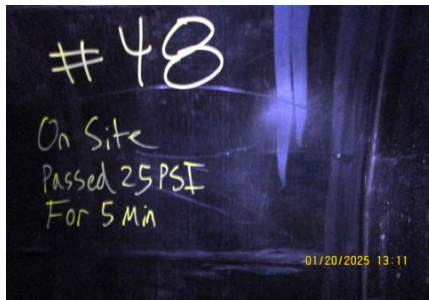
AID MCPH2 - Sta 850+25 54-IN ID profile wall HDPE pipe field joint #48 air pressure test PASS 01-20-25

- 1) Pipe entry under Contractor established confined space program, routine air monitoring of pipe interior provided in the work zone.
- 2) Pipe pre-heating prior to field joint welding conducted in accordance with pipe manufacturers instructions.
- 3) Contractor QC includes air pressure testing all field joints 25 psi, 5 minutes, no pressure loss accepted.
- 4) Contractor QC includes pipe slope measurement on flow line of installed pipe. Mark measured slope on the pipe flow line, corrective action required any location with reverse pitch.
- 5) Protect-in-place private utilities and improvements as indicated on the plan. Other private utilities encountered in the course of the work to be protected-in-place or removed / replaced in kind, coordinate with the utility owner.

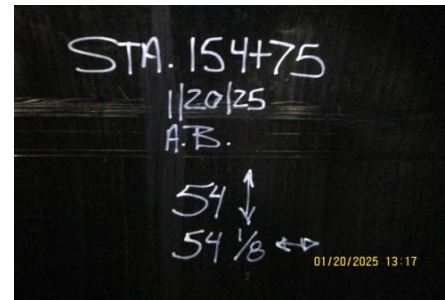
Conducted ovality measurement installed 54-IN profile wall HDPE pipe using tape measure vertical and horizontal axis Sta. 854+75; vertical 54-0/0" horizontal 54-1/8", after backfill. Reference specification 02300 and 15068 for ovality criteria; 1% of pipe diameter = 1/2", ovality measurement Sta. 854+75 within allowable deflection limits, after backfill. (Photo.)

AID MCPH2 - Sta 854+75 54-IN ID profile wall HDPE pipe QA ovality measurement after backfill 01-09-25

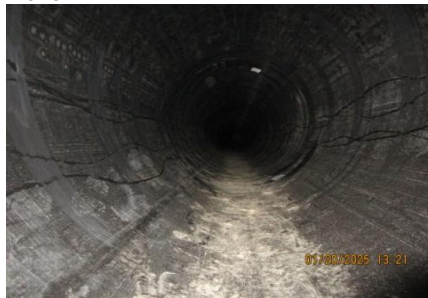
AID MCPH2 - Sta 854+00 54-IN ID profile wall HDPE pipe QA interior after backfill 01-09-25

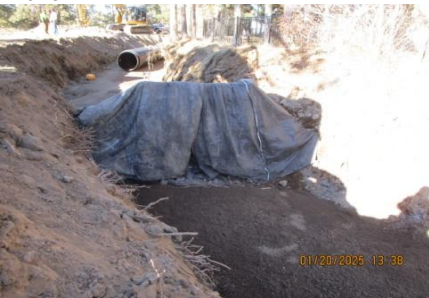
AID MCPH2 Seg2 - Sta. 848+00 existing (2) x 3-IN private water protect-in-place, abandon in place existing irrigation water and power 01-20-25

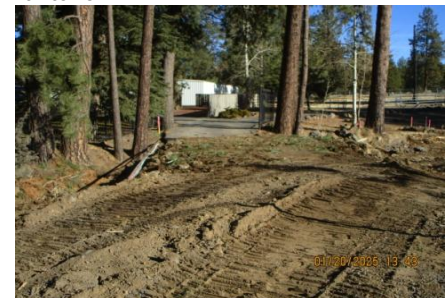
Contractor continues selective demolition of pedestrian bridges and irrigation turnout head gate structures approximate Sta 720+00 to Sta. 867+98 east as pipe trench excavation progresses westbound. Selective demolition complete includes removal of bridge structure Sta. 847+50, private access way crossing MCPH2 pipeline. Temporary access to private property provided with access way backfill to travel grade. Utilities associated with the subject bridge crossing are protected-in-place. Selective demolition in general accordance with Specification 01732 - Selective Demolition. (Photo)

AID MCPH2 Seg2 - Sta. 847+50 existing bridge and abutments removed, temp access provided 01-20-25

- 1) Selective demo, protect-in-place weir boxes to remain, maintain access at vehicular bridge removed, salvage items where noted on Dwgs.
- 2) Utility locate, utility coordination, temp. traffic control plans at unmarked private utility crossings and existing access ways.
- 3) Krah pipe revised lay drawings and warranty document submittals required.

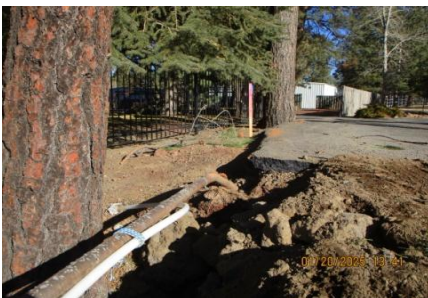
AID MCPH2 Seg2 - Sta. 847+50 existing private water and communication utilities, protect-in-place 01-20-25

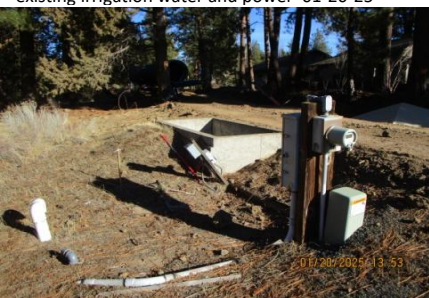
AID MCPH2 Seg2 - Sta. 849+50 irrigation weir box and private electrical, protect in place 01-20-25

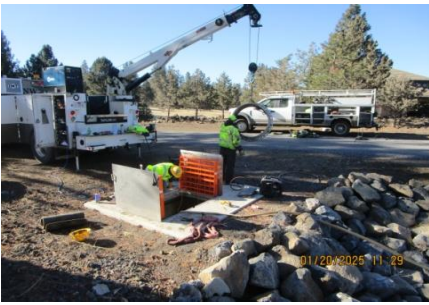
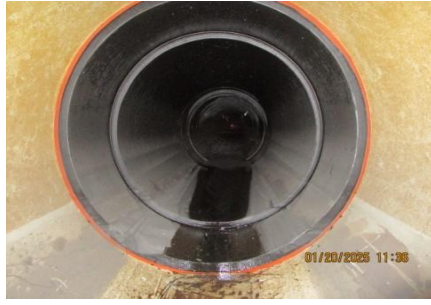
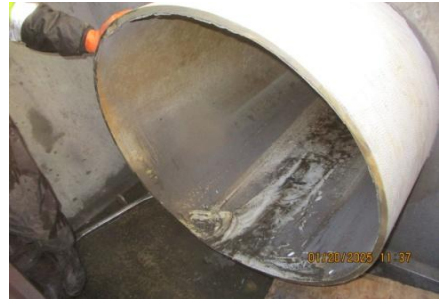
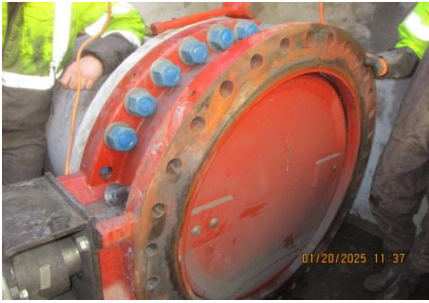
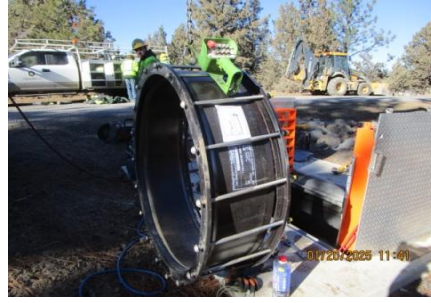
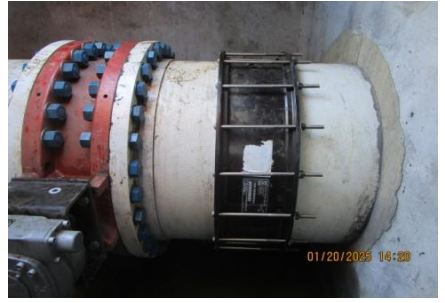
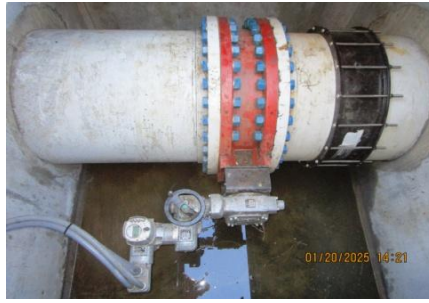
AID MCPH1 - Sta. 1067+09 Warranty Issue 01 36-IN coupler install (1) 01-20-25

AID MCPH1 - Sta. 1067+09 Warranty Issue 01 36-IN coupler install (2) 01-20-25

AID MCPH1 - Sta. 1067+09 Warranty Issue 01 36-IN coupler install (3) 01-20-25

AID MCPH1 - Sta. 1067+09 Warranty Issue 01 36-IN coupler install (4) 01-20-25

AID MCPH1 - Sta. 1067+09 Warranty Issue 01 36-IN coupler install (5) 01-20-25

AID MCPH1 - Sta. 1067+09 Warranty Issue 01 36-IN coupler install (6) 01-20-25

AID MCPH1 - Sta. 1067+09 Warranty Issue 01 36-IN coupler install (7) 01-20-25

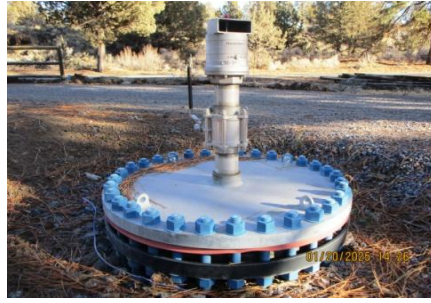
AID MCPH1 - Sta. 868+13 892+80 900+20 Warranty Issue 02 4-IN Ball Valve Install 01-20-25
