DAILY MONITORING REPORT

PROJECT NAME: Arnold Irrigation District - MCPH2 Seg2 YR 2024 / 2025	CONTRACT NO: AID MCPH2 Piping Project
LOCATION / STA.: AID MCPH2 Segment 2	ID NUMBER: AID - MCPH2 Seg2

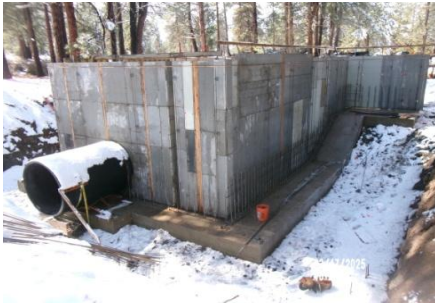
AID MCPH2 - Sta 718+00 Intake Structure wall form and wall reinforcing steel in process (1) 03-17-25
